# Mandatory Service Bulletin

## ENGINE COMPONENTS, INC.

S.B. No.: **03-7**

**Title: CYLINDER REPLACEMENT**

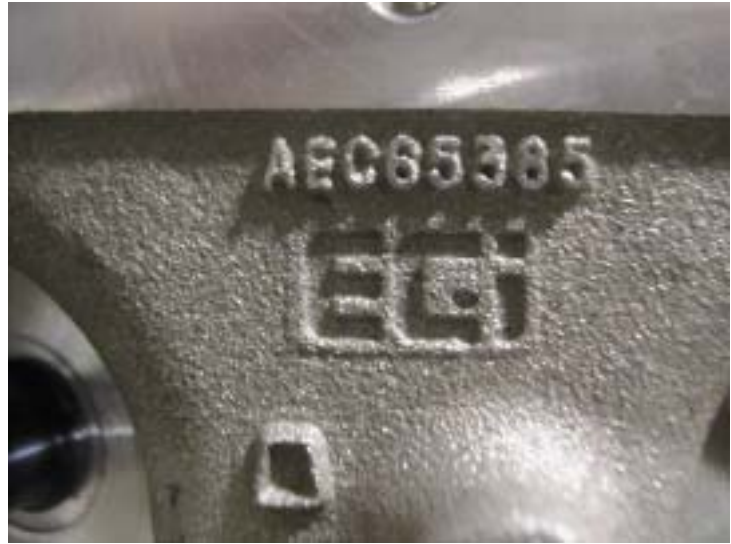
Photograph 1

- a. Determine that the engine is a TSIO-520 that has been approved for operation at 325 to 335 HP.
- b. Remove the engine upper cowl and release the left side cowl and allow it to hinge down. Remove the rocker box cover from the left front cylinder. Determine if the left front cylinder casting is an ECi Part No. AEC65385 replacement cylinder as shown in Photograph 1. Verify that the cylinder head marking is identical to Photograph 1, with the part number between the ECi logo and the rocker box flange. Also, the letter “O” will be below the logo as shown.

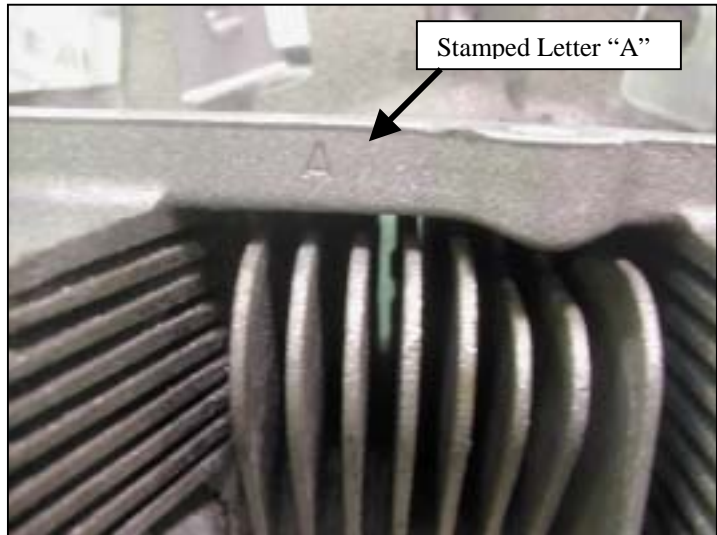
Photograph 2

- c. If the cylinder is identified as an ECi replacement cylinder with the identification shown, then view the rocker box flange from the top of the cylinder. Determine if there is the letter “A” stamped on the rocker box flange as shown in Photograph 2. If the letter “A” is stamped on the rocker box flange, then no further action is required. Record the inspection in the engine logbook and return the airplane to service.

- d. If there is no letter “A” stamped on the cylinder head rocker box flange, then contact ECi Customer Service or your overhaul facility to schedule cylinder replacement at no charge to the owner/operator. ECi will send replacement cylinder assemblies to the owner/operator for change and pay reasonable costs for the cylinder change.
- e. All removed cylinders must be returned to ECi for evaluation. Additionally, please provide details of cracked or broken cylinder heads to the FAA’s Fort Worth Aircraft Certification Office (Mr. Richard Karanian, SW-190, 817-222-5195).
- f. Any alternative method of compliance to this Mandatory Service Bulletin should be evaluated by ECi Engineering before accomplishment. Accordingly, contact ECi Customer Service to schedule consultation with ECi engineers.
